This Carolina Thomas Bus Buzz is a friendly reminder to all North Carolina LEA's to verify you have performed SF249A on all older FS65's with Caterpillar engines.

Reminder of Issue Communicated Previously Per Field Service Campaign SF249A from 2002

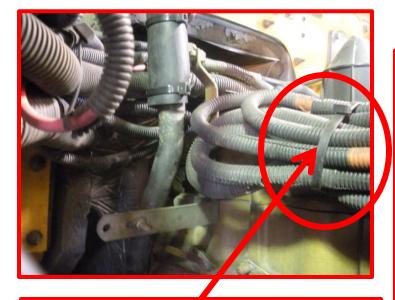
Proper P-Clamp of wires above exhaust manifold.

When inspecting units we are still noticing that some units still have zip ties securing wire looms above the exhaust manifold. Wiring looms above the exhaust manifold should not be secured with zip ties. They should be P-clamped to the valve cover to avoid failure of zip ties due to heat per SF249A. Zip ties this close to the exhaust heat can weaken over time and then allow the wiring to drop down on hot exhaust components. See Photos. A copy of SF249A is posted on our website for your convenience in the Carolina Thomas Bus Buzz section.

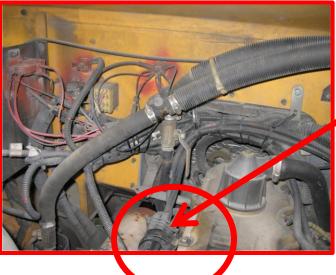
<u>Improper use</u> of zip ties on looms above exhaust manifold.
