This Carolina Thomas Bus Buzz informs you of a Thomas Product Service Bulletin C2-12 Bulletin 13.

MODEL: C2

SUBJECT: CHASSIS PDM POWER CABLE CHAFING

BULLETIN: 13

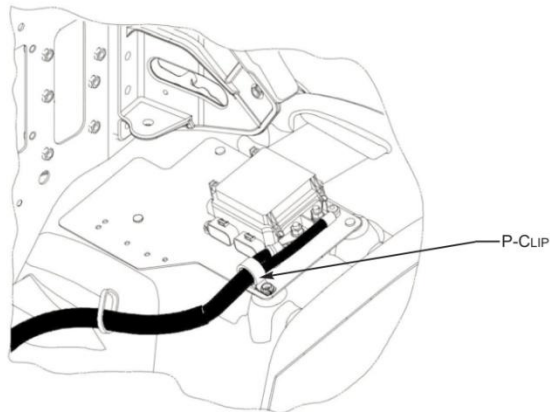
FIGURE 1

Inspection: Check the unit for the presence of a P-Clip as shown in Figure 1. If P-Clip is present, no further action is required.

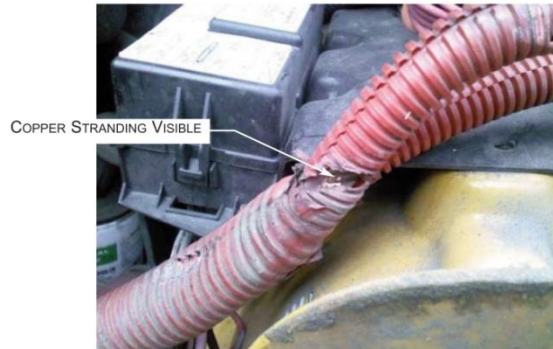
FIGURE 2

1. Make sure the ignition is in the "Off" position. Chock the tires and disconnect the batteries.
2. Inspect the Chassis PDM power cable for chafed insulation. The harness loom may need to be pulled back for proper inspection. Check the top and bottom of the cable insulation for visible signs of copper stranding.

- 3.1 If no copper is visible and the insulation is adequately protecting the power cable, proceed to step 7.
- 3.2 If the insulation has been damaged with copper stranding visible, continue to step 4.
- 3.3 If the insulation and copper stranding have been damaged, replace the cable and proceed to step 7.
4. Protect the open copper strands by applying heat-shrink over the damaged insulation. Disconnect the cable with damaged insulation from the Chassis PDM. Pull back the cable loom to access damaged cable insulation.

NOTE: The heat-shrink (TBB 61201955) is 6 inches long. Normal chafing should require 3 inches of heat shrink to repair worn area with adequate good insulation overlap. Cut the heat-shrink into two equal lengths for this repair.

5. Slip the heat-shrink (TBB 61201955) over the cable terminal and center its length over the power cables worn insulation. Heat the heat-shrink evenly until it fully conforms to the cable and adhesive is visible at each end. Re-apply the loom that was pulled back.
6. Reconnect the chassis power cable(s) to the chassis PDM using the existing hardware. Torque range for the fasteners is to be 5-10 FT-LBS.
