Corrosion Protection Efforts Implemented by Thomas Built Buses on the Saf-T-Liner C2

Rear Emergency Door and Side Lift Door changed to galvanized steel to offer additional corrosion protection.

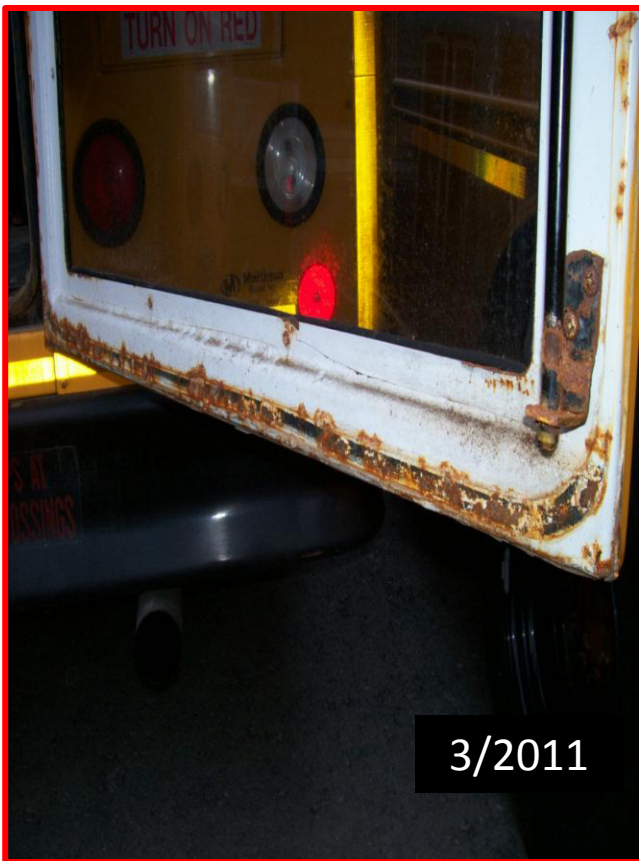
Corrosion effects on cold rolled steel material in doors.

**Rear interior door
rust shown after
salt spray tests**

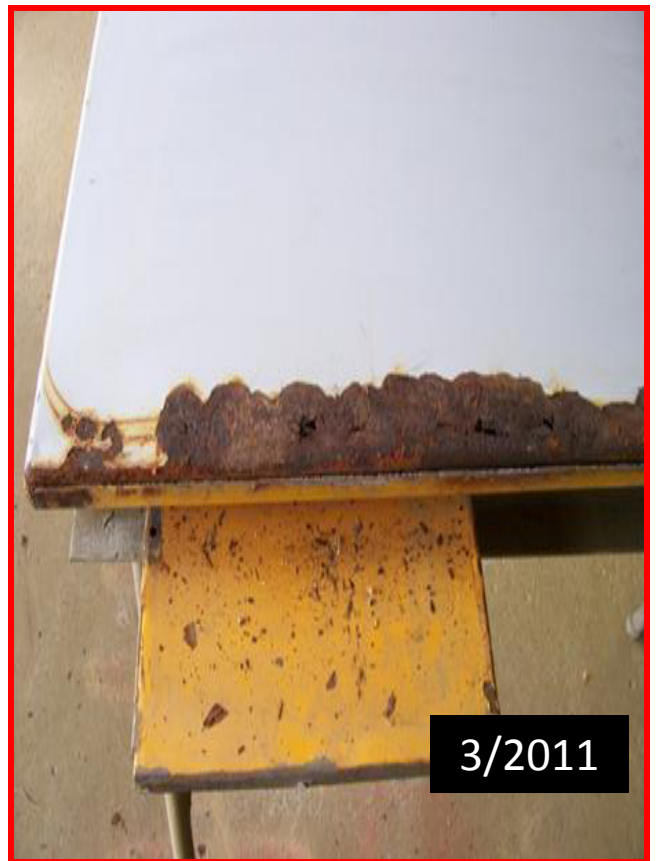
**Rear interior door
shown with rust
perforation after
salt spray tests**

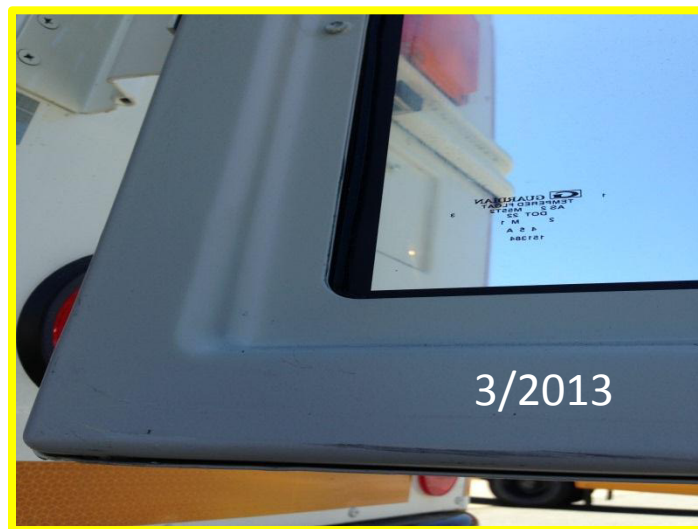
Interior door skin after salt spray tests. Bottom inside corner of door.

Saf-T-Liner C2 rear door and lift door improved with galvanized steel for superior corrosion protection.

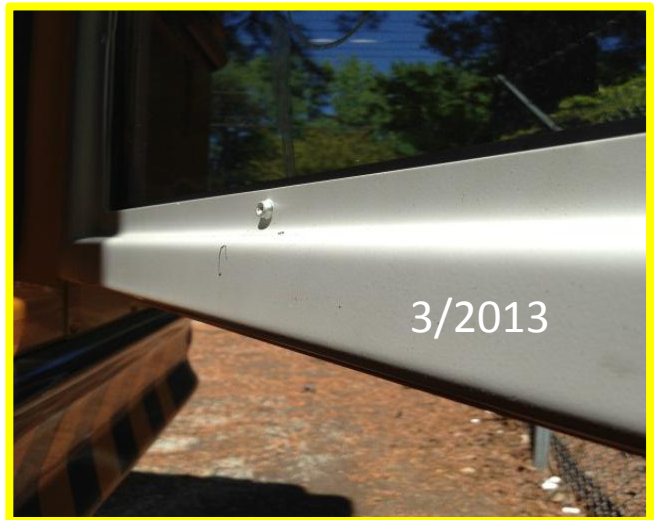
Interior door skin after salt spray tests . Bottom inside edge of door.

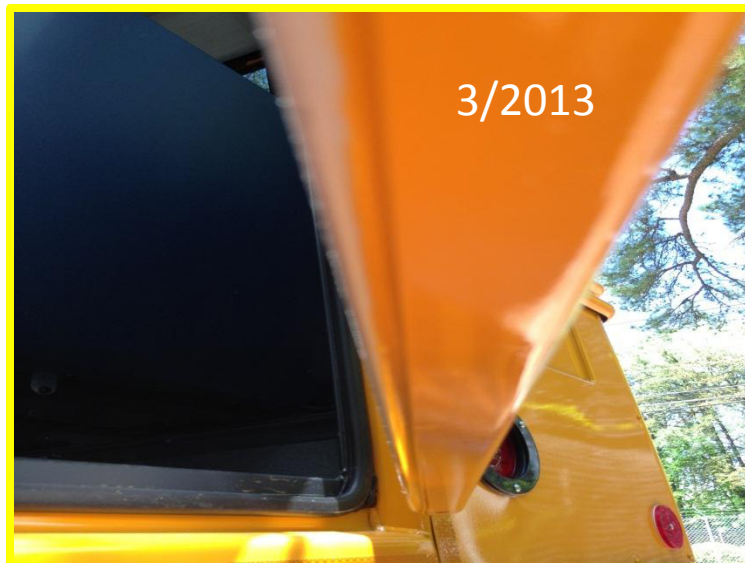
Bottom edge of exterior door after salt spray tests.
