Subject: Storage Box Bracket Repair

Carolina Thomas Bus Buzz #37 is providing service information on the bracket that supports the storage box on C2's. Currently, the bracket is bolted to the chassis frame rail. This repair procedure includes instructions on replacing this bracket to one that supports the box from the bus floor. This is a warrantable repair on a bus that is within its 5-year life.

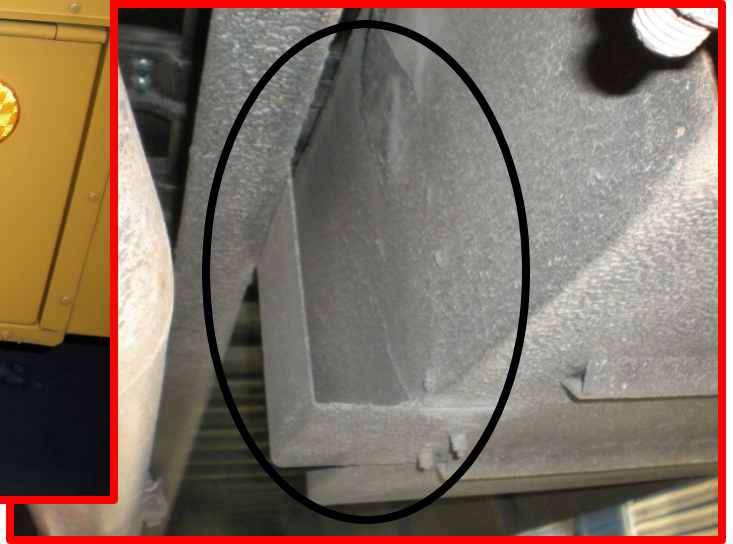
Photo on the right shows the original storage box mount and its support bracket bolted to the frame rail. Because the frame rail flexes differently than the side skirt, the storage box support bracket can crack and needs to be replaced.

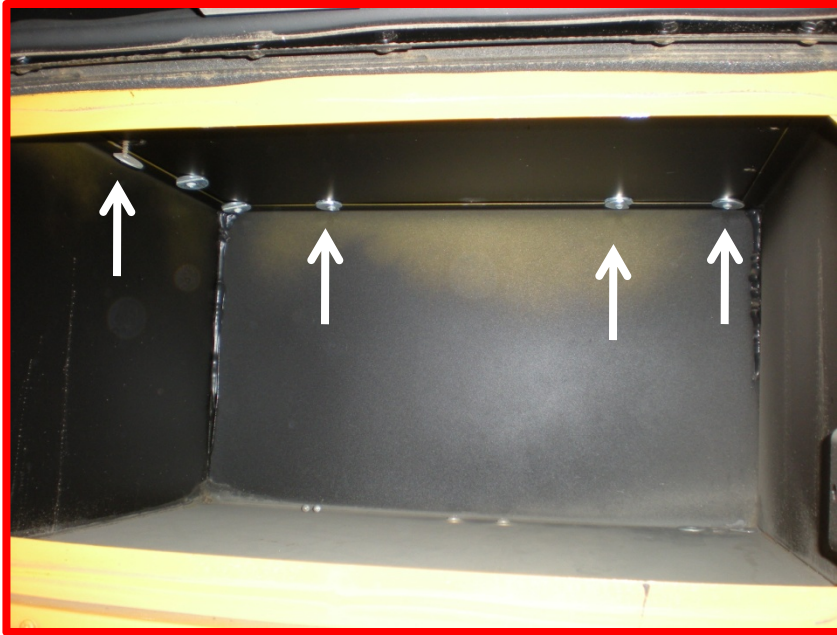
Step 2: Open storage box door and remove fasteners securing the top of the storage box lid (indicated above).

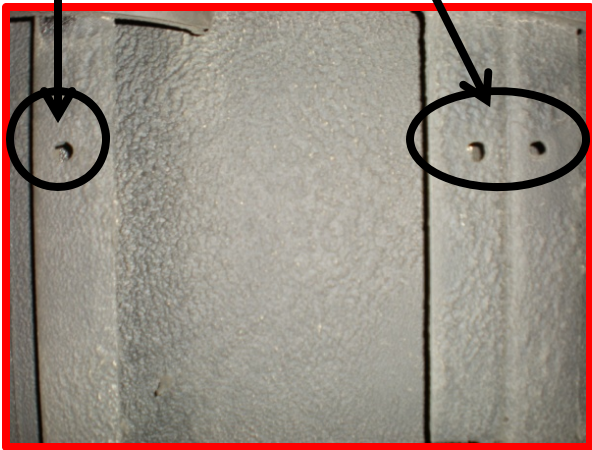
Existing holes in bus floor are shown to left. They are readily accessible with the lid of box removed.

Holes shown in bus floor above storage box
