**Buzz Here! Calling all
NC County Technicians.**

**Subject: Air fan hub
rotary union bearing on
Mercedes engine C2's -
wearing out.**

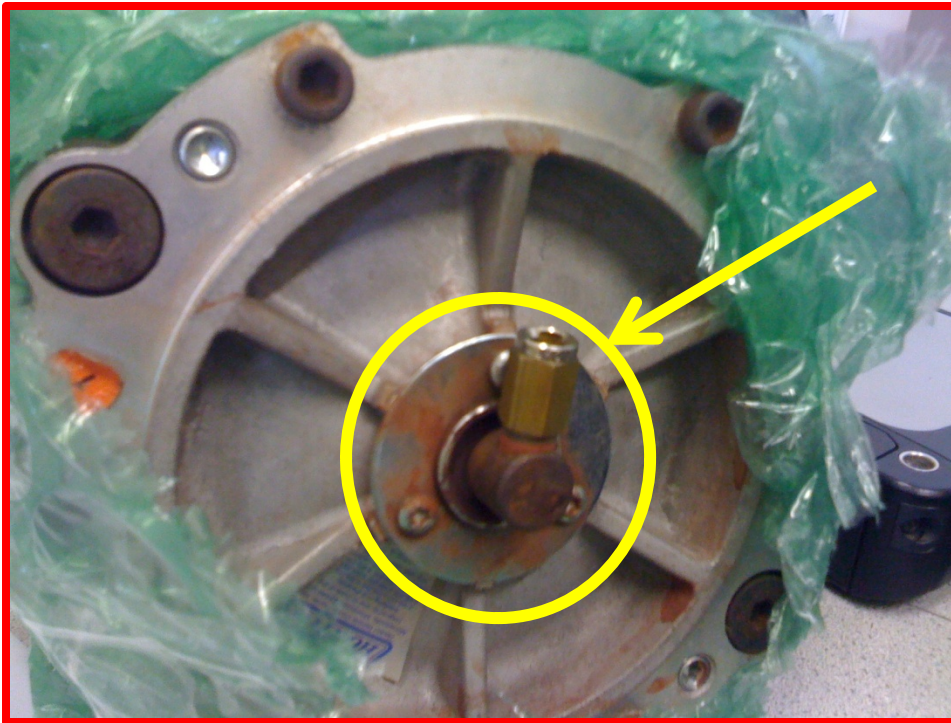
We are hearing reports that the small bearing in the air driven fan hubs (rotary union) on the Mercedes Engine C2's is starting to wear out.

Guys, you are looking for this rotary union on the back of the fan hub.
