C2 Battery Box Tray Slides - Rollers Wearing Through The Slide.

C2 Battery Box Tray Slides

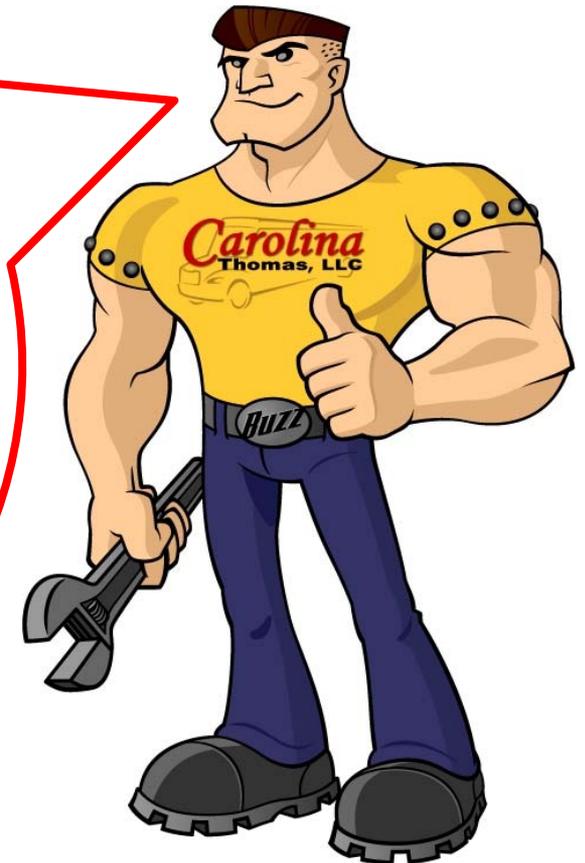
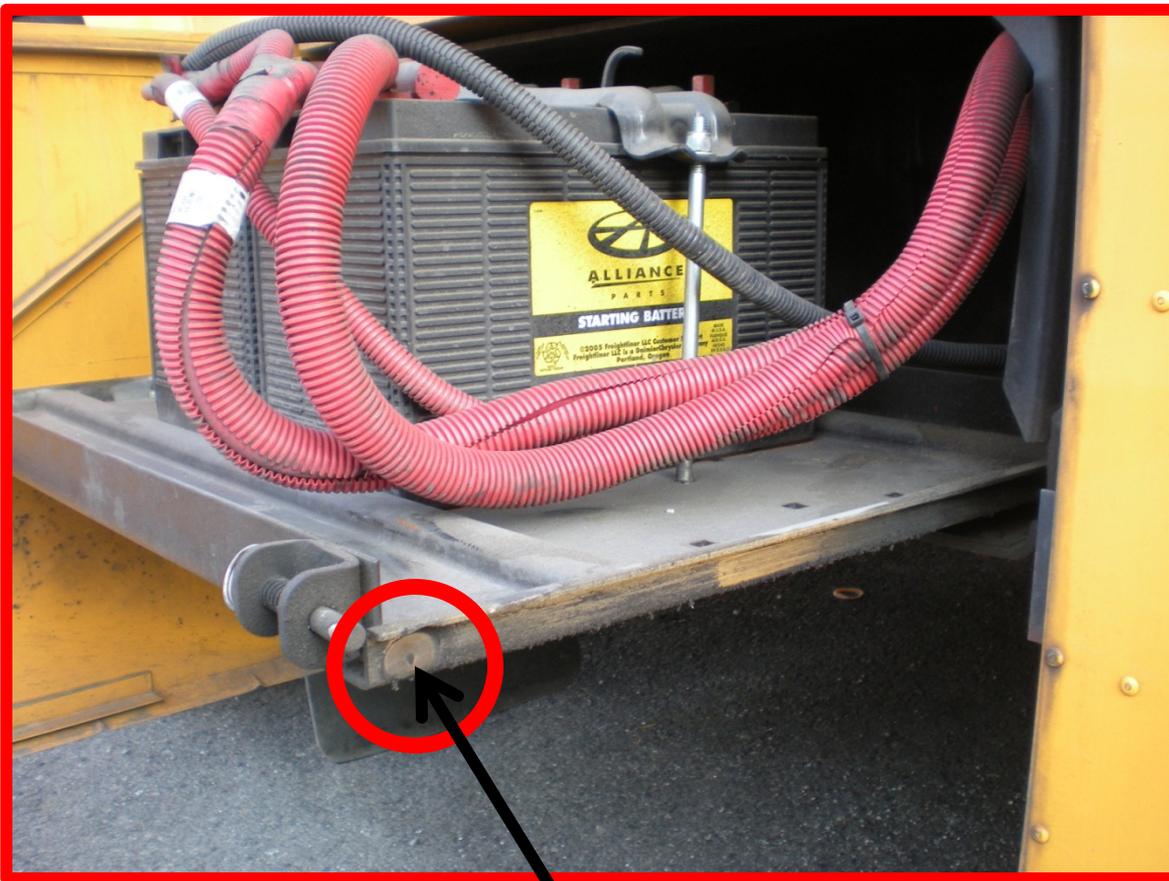
Area indicated is the where the roller rests on the battery tray slide when the box is closed. This photo shows the battery tray extended out for service.

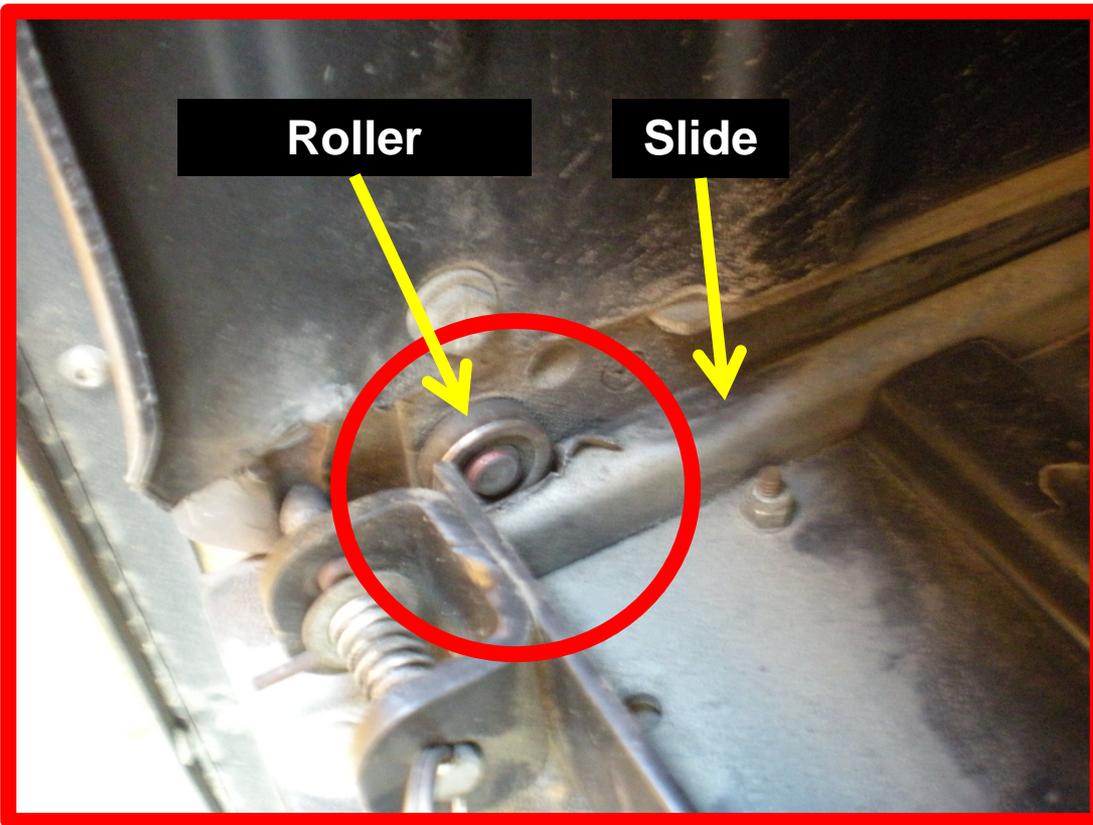
Photo indicates tray slide roller that is wore completely through the battery tray slide. You can see roller pushed up through the slide in this photo. This photo shows the battery tray closed as if the bus was in operation.

We need feedback from you on this. Please start watching your units and if we need to do something here for you please let us know. You can contact Woody Corder or Kerry Loggins as follows:

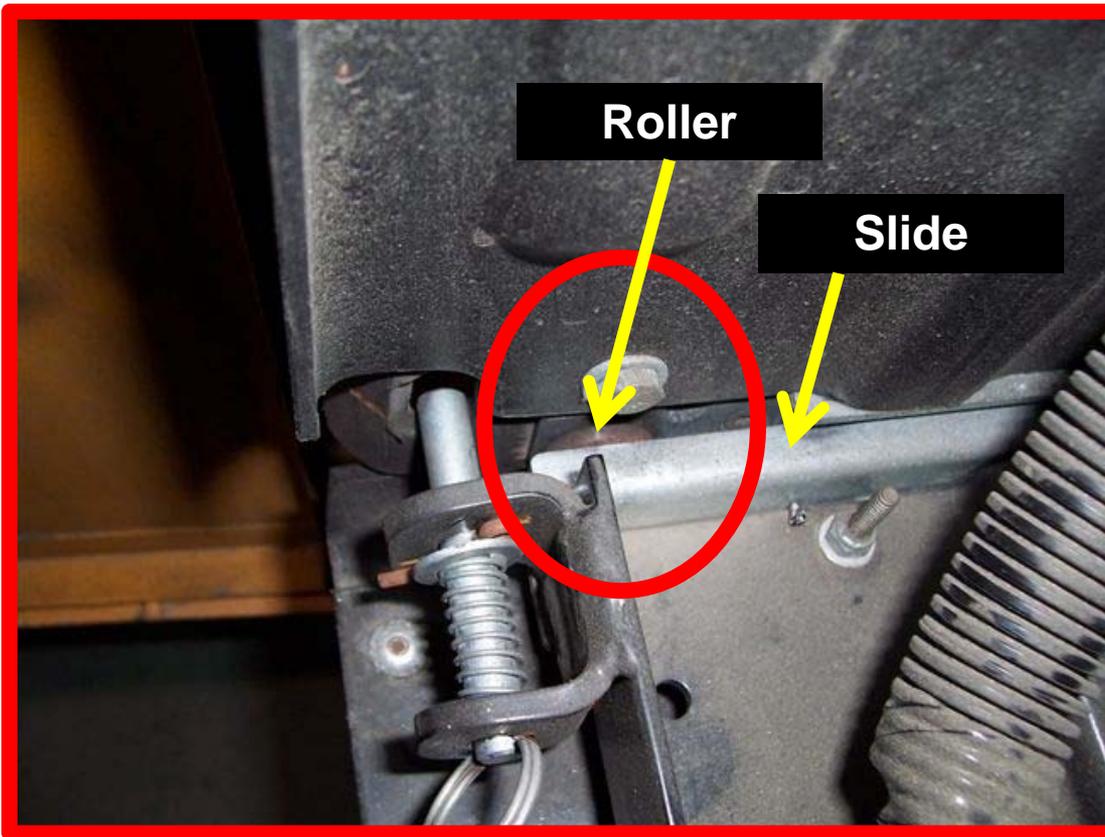
Photo indicates tray slide roller that is in good condition and should allow the batteries to be pulled and serviced easily. This photo is also taken with the battery tray closed as if in operation.
