This Carolina Thomas Bus Buzz addresses a condition where the Grid Heater Power Cable for Caterpillar engines can chafe the ¼ turn heater shutoff valve on an FS65 with Caterpillar engine.

Condition: The Caterpillar Engine Grid Heater Wire Can chafe the ¼ turn shutoff valve and cause a direct short resulting in severe damage to the bus.

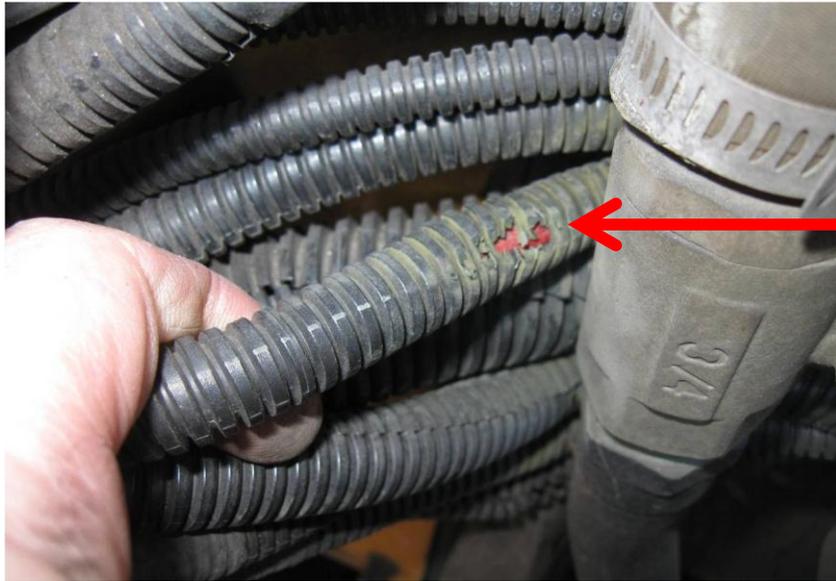
Photo shows convoluted harness protection with medium damage (chafed through protective wrap but NOT into cable covering). Cable had to be pulled away to view.

7. Minor and/or medium damage to cable can be repaired with heat shrink protection as shown. Cable should then be protected with convoluted tubing and secured away from ¼ turn shutoff valve with 50# tensile strength zip ties (part # 23-09796-509). NOTE: If power cable is chafed through coating to copper wire we recommend that it be replaced before the bus is put back into service.

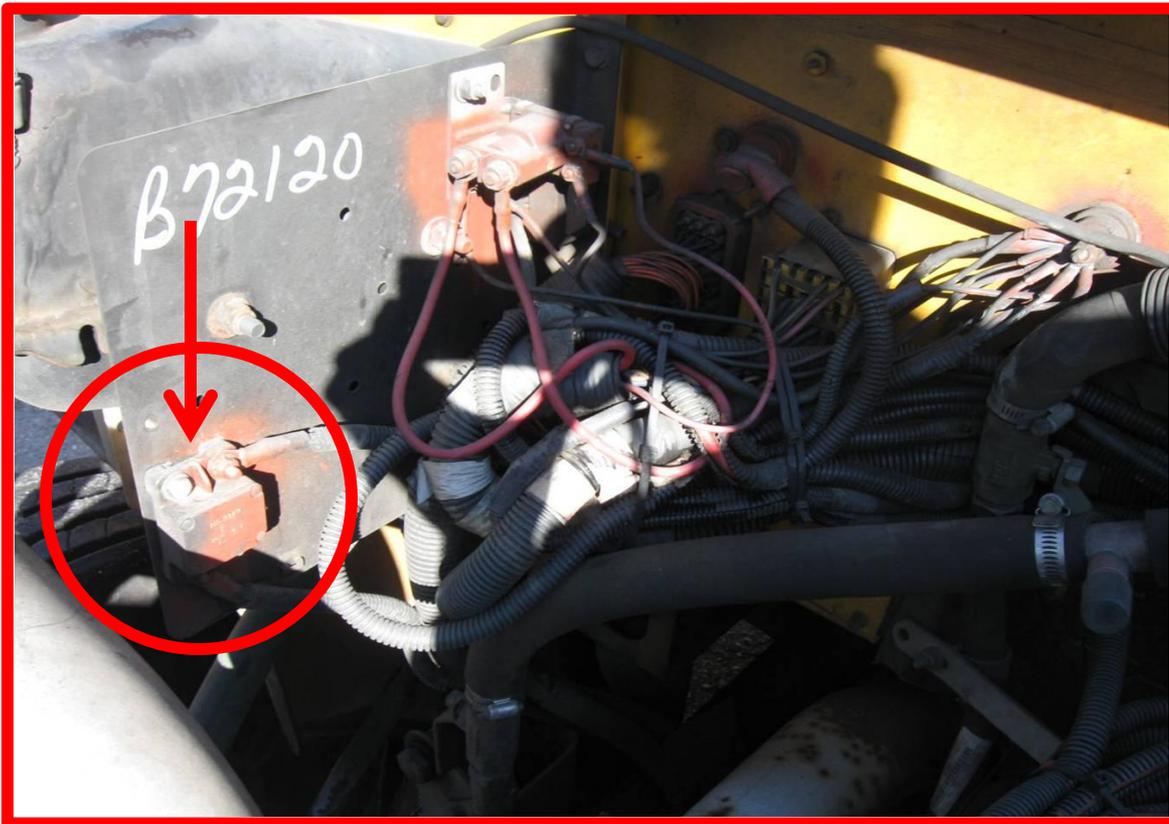
NOTE: Grid Heater Wire connects to power relay by surge tank for reference (area circled.)
