We have had a request for instructions on how to replace the 50 AMP CR relay in the A/C electrical box with the upgraded 70 AMP relay.

This Carolina Thomas Bus Buzz provides instructions as to how we go about this and before and after photos for reference.

This is only applicable to older C2's and you must contact us prior to repairs for pre-approval and the components to make sure a unit is covered.

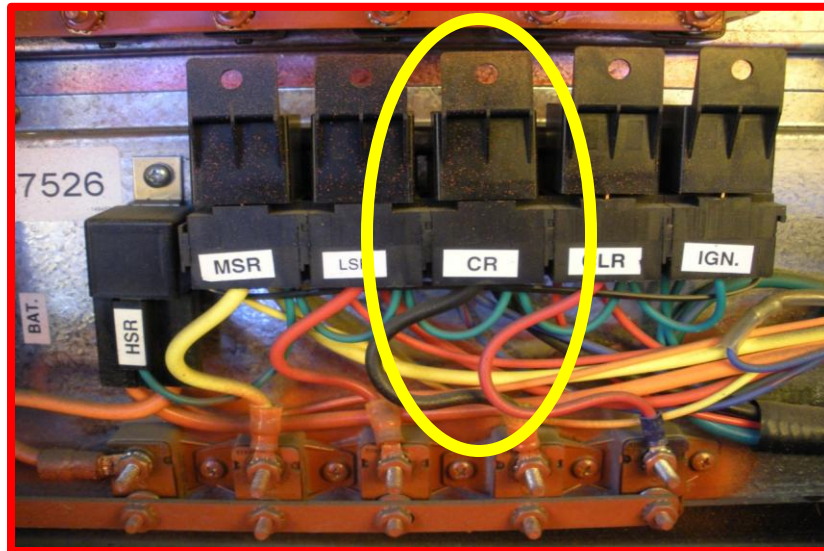
This photo shows the AC electrical box wiring and the 50AMP CR relay **BEFORE** the repair upgrade.

The CR 50 AMP relay (marked below) is the relay we are upgrading to a 70 AMP relay.

Before any repairs begin, all safety precautions should be adhered to by chalking the wheels, removing the ignition key and then disconnecting the batteries to make sure the vehicle will not move or be accidently engaged during the repair. You must disconnect the battery power before beginning this repair.

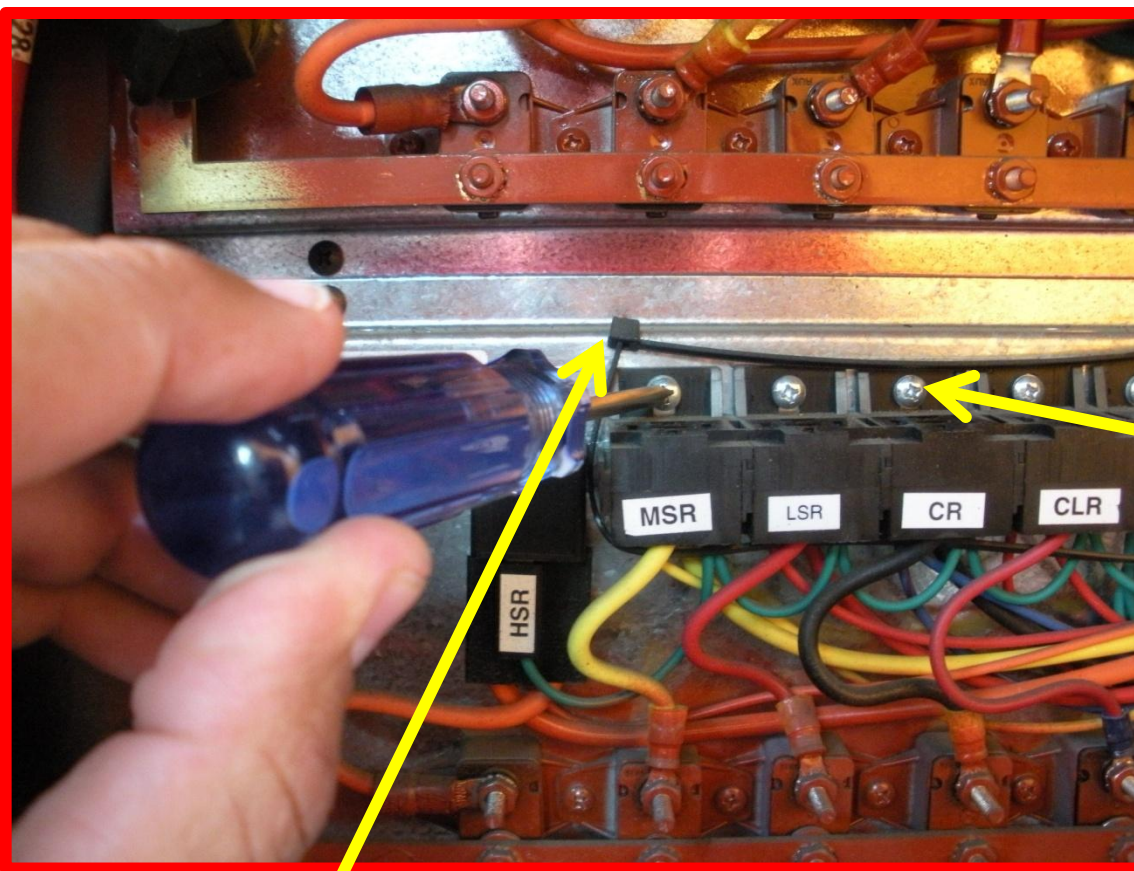
Notice that a tie wrap is used to hold relays tight into the holders during operation. This can be discarded and replaced later when this repair is complete.

Step 4: Behind the A/C relays are 5 screws to remove to allow relay receptacles to be removed. Remove these screws so you can separate and access the CR 50 amp relay.

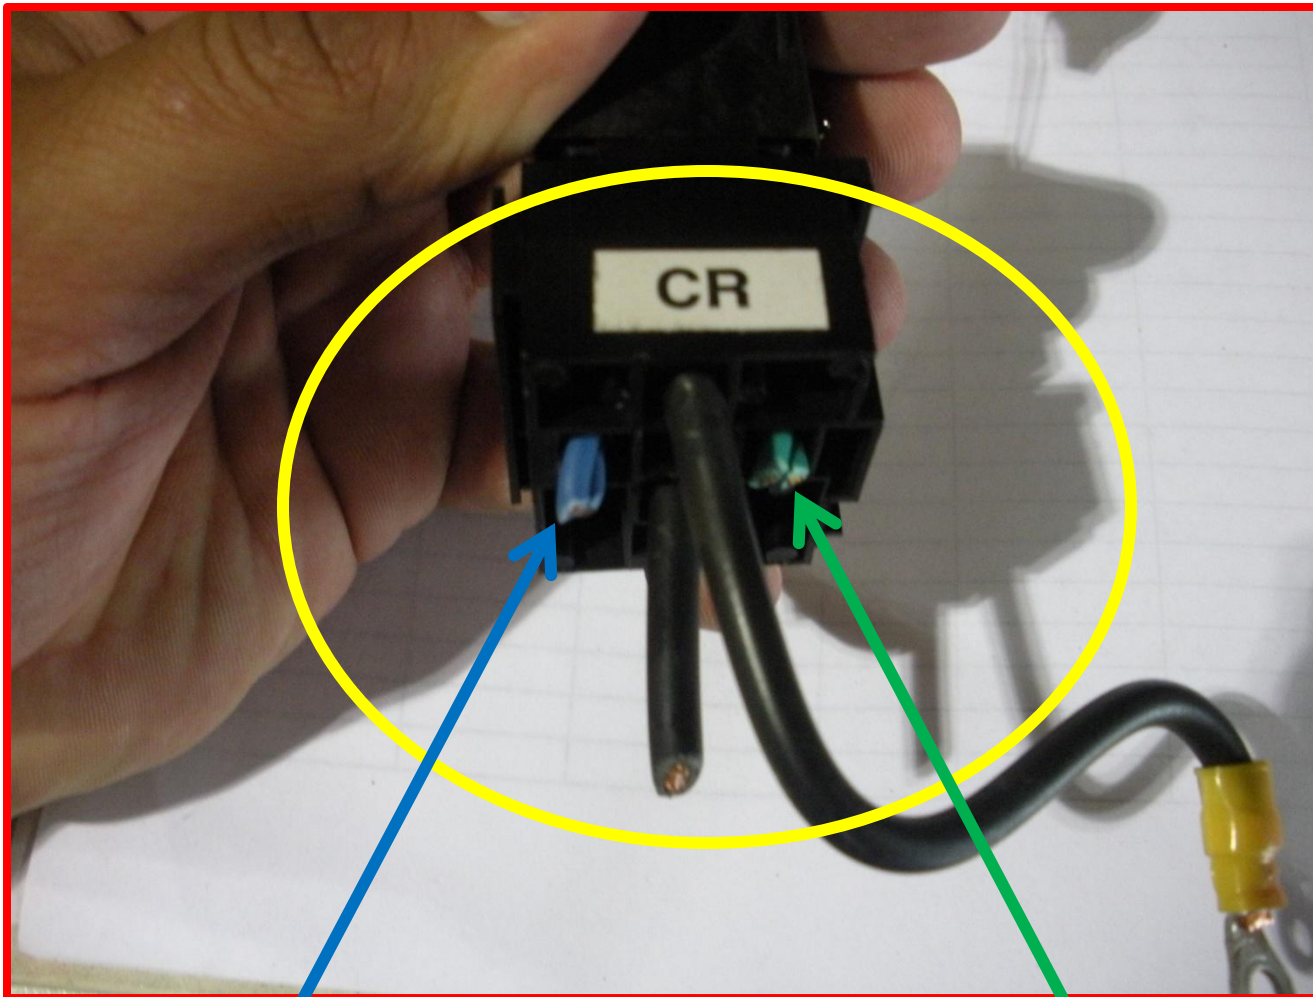
Two **BLUE** wires cut.

Two **GREEN** wires cut.

Step 5: Once all relay holders are loose you will cut the wires as shown as close to the CR relay holder **ONLY** so most of the wire stays in the A/C electrical box for use in a later step. Save the parts as you will have to return these to us in order for us to cover this under warranty.
