This Carolina Thomas Bus Buzz informs you of a Thomas Product Service Bulletin C2-12 Bulletin 13.

MODEL: C2

SUBJECT: CHASSIS PDM POWER CABLE CHAFING

BULLETIN: 13

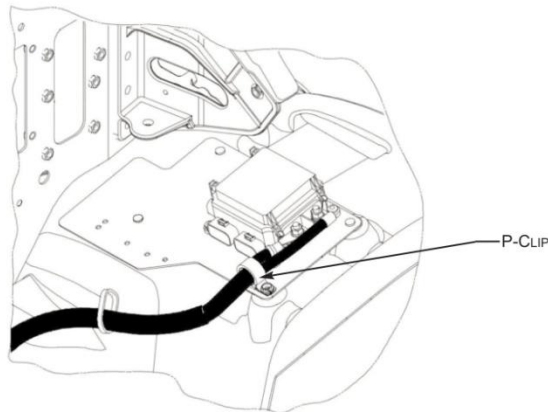
FIGURE 1

Inspection: Check the unit for the presence of a P-Clip as shown in Figure 1. If P-Clip is present, no further action is required.

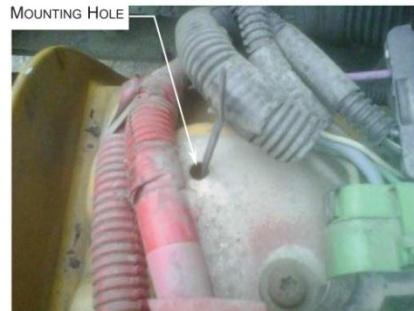
FIGURE 3

7. Locate the unused hole in the PDM mounting plate close to the power cable. **Figure 3**
8. Open the P-Clip (TBB 61480924) and install around the chassis PDM power cable that is closest to the unused hole. **Figure 4**

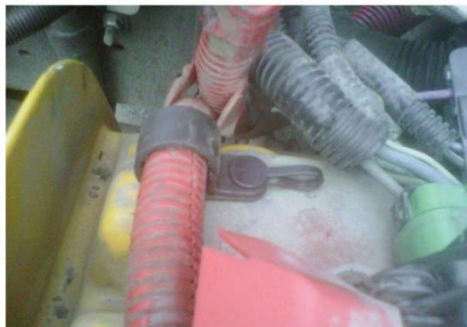
FIGURE 5

9. With the locking pin still hanging loose on its tether, push the mounting barb completely into the hole in the chassis PDM mounting plate.
10. Once the P-Clip and power cable are positioned correctly, fully install the locking pin through both tabs of the P-Clip. The locking pin will close the P-Clip and expand the mounting barb locking it to the plate. **Figure 5**

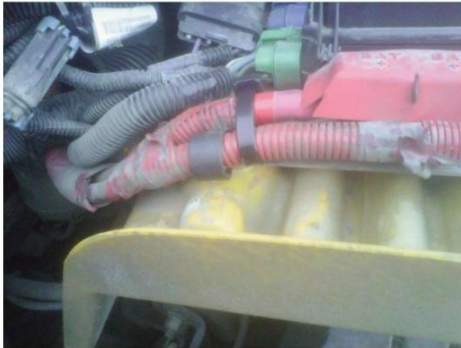
FIGURE 6

- Use the Tie Wrap (TBB 61370022) to secure the second chassis PDM power cable to the first now retained by the P-Clip. When the second power cable is positioned correctly, tighten the tie wrap and trim off the excess tail. **Figure 6**
