Fuel Tank Improvements

Complaint - Premature fuel tank corrosion

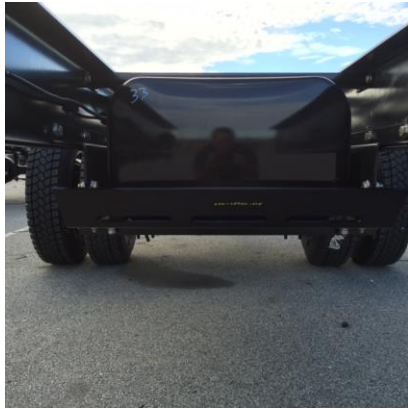
Improved std top coat

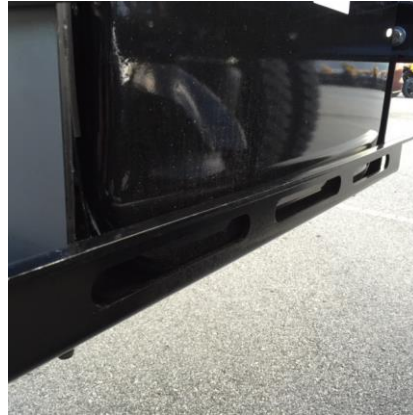
Drainage slots

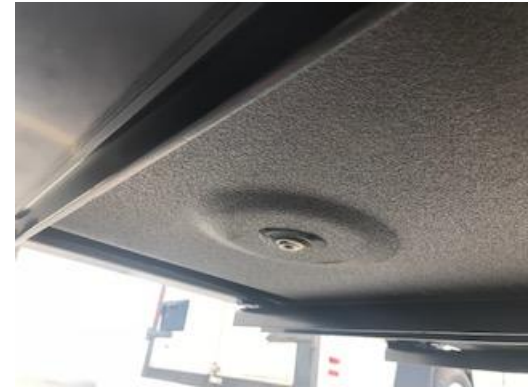
Sump Drain

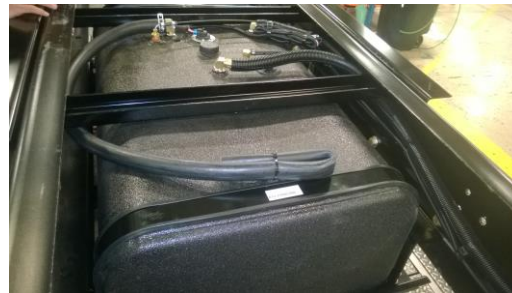
Optional - Polyurea coating
