**Buzz Here! Calling all NC  
County Transportation  
Service Technicians.**

**Subject: Fuel leak at fuel  
pump on Cummins ISB  
engines.**

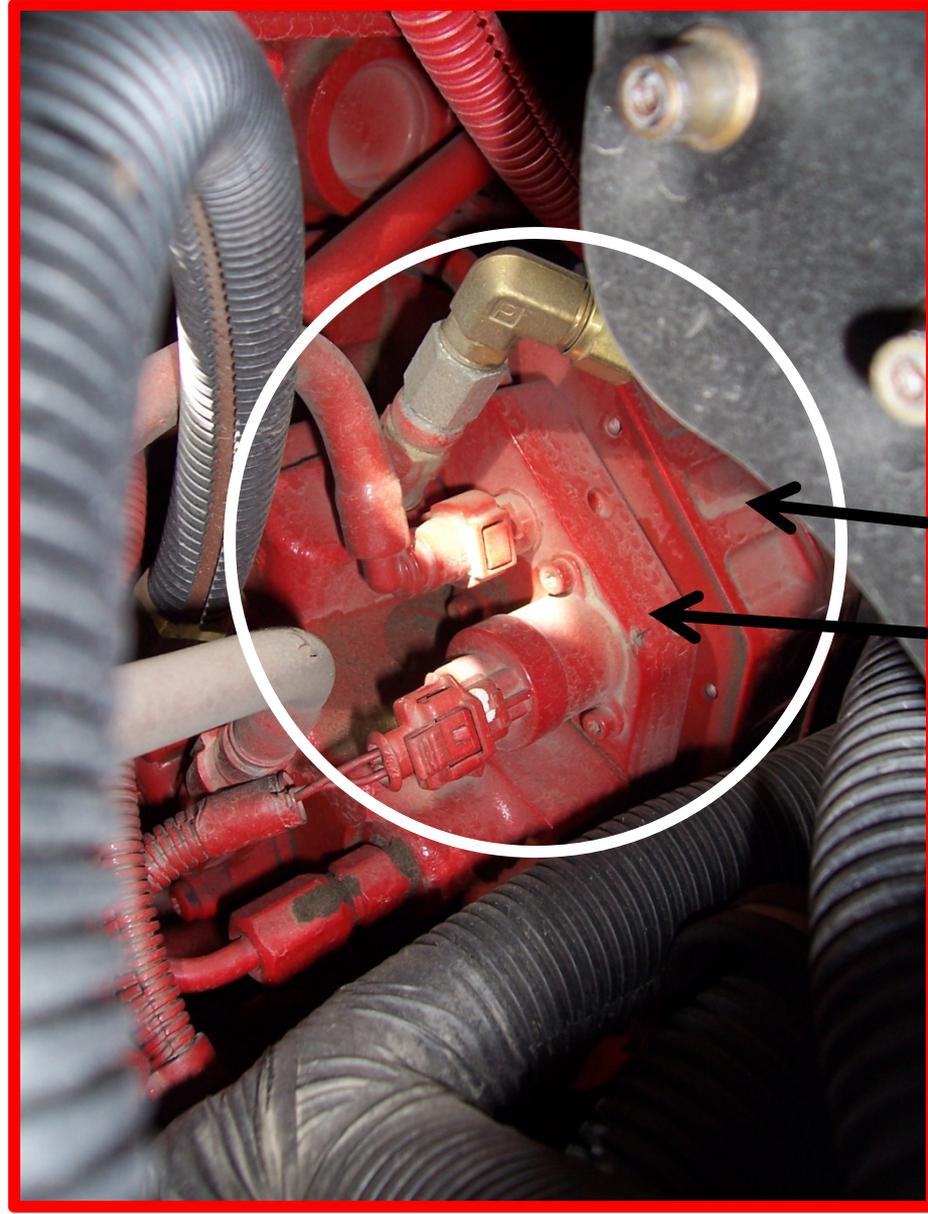
Fuel pump

Fuel Manifold

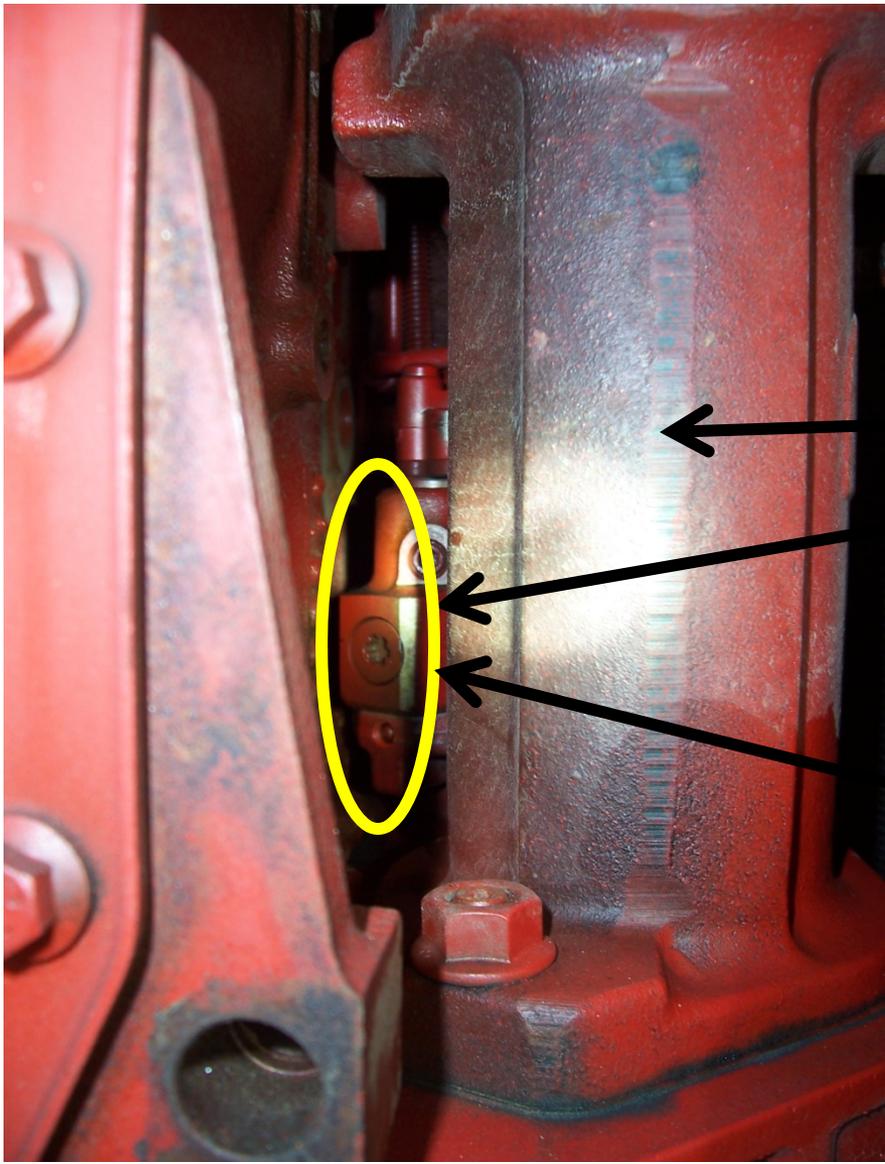
Top View – Fuel Pump – Driver’s side of Engine

← Air Compressor  
← Fuel pump

Area to inspect for fuel leak or fuel seepage. Leak is usually on the bottom side.

**If you discover fuel seepage in this area, we can assist you in getting you in touch with the closest authorized service center or Carolina Thomas can do the repair if needed in our shop.**
